Subject: MS4 Annual Report for NPDES Permit No. ILR400494

Division of Water Pollution Control
ANNUAL FACILITY INSPECTION REPORT
for NPDES Permit for Storm Water Discharges from Separate Storm Sewer Systems (MS4)

Report Period: From March, 2025 To March, 2026

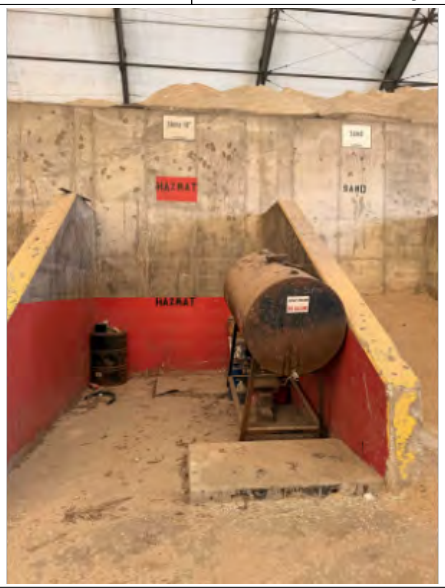
Task ID: 25-122939		Asset ID: Facility Site M01			
Photo No.	1	Date	11/14/2025	Time	12:00 PM
Comments:		Direction	North	Photo Taken By	ReganW
Action Item: Place a drip pan under the emulsion tank. **RESOLVED (12/4/25)**

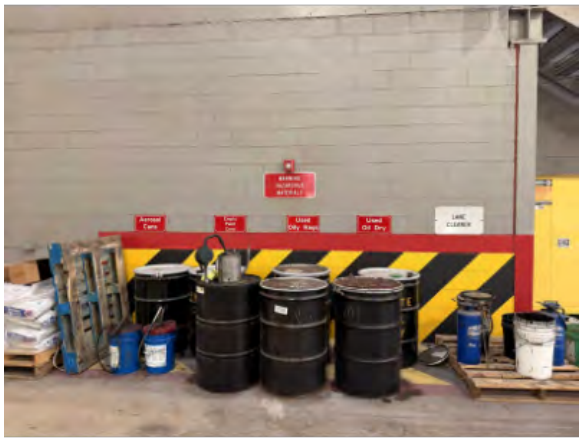
Task ID: 25-122939		Asset ID: Facility Site M01			
Photo No.	2	Date	11/14/2025	Time	12:00 PM
Comments:		Direction	North	Photo Taken By	ReganW
Action Item: Clean hazardous waste area, remove all non-hazardous items **RESOLVED (12/4/25)**

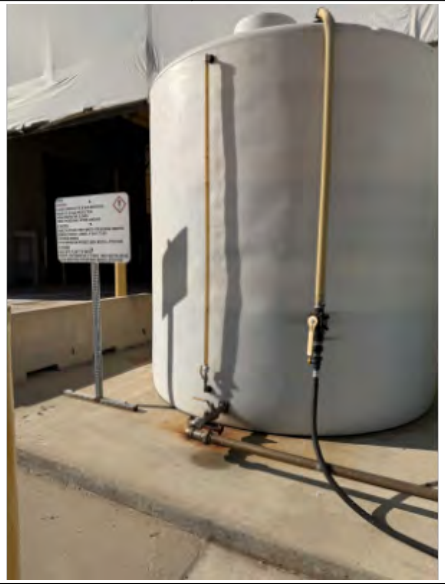
Task ID: 25-122939		Asset ID: Facility Site M01			
Photo No.	6	Date	11/14/2025	Time	12:00 PM
Comments:		Direction	West	Photo Taken By	ReganW
Brine AST valve closed when not in use

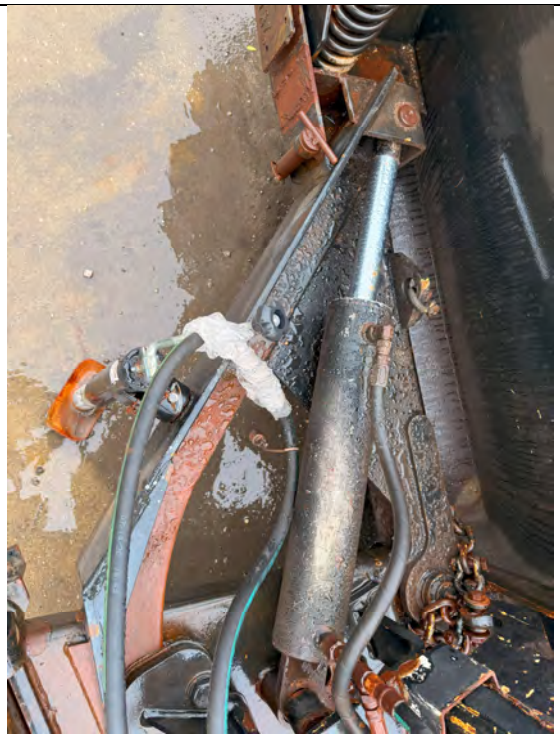
Photo No.	1
Date	6/04/2025
Time	12:45 PM
Direction	East
Photo Taken By	GG
Comments Fuel AST.

Photo No.	2
Date	6/04/2025
Time	1:00 PM
Direction	West
Photo Taken By	GG
Comments Hydraulic lines capped/wrapped.

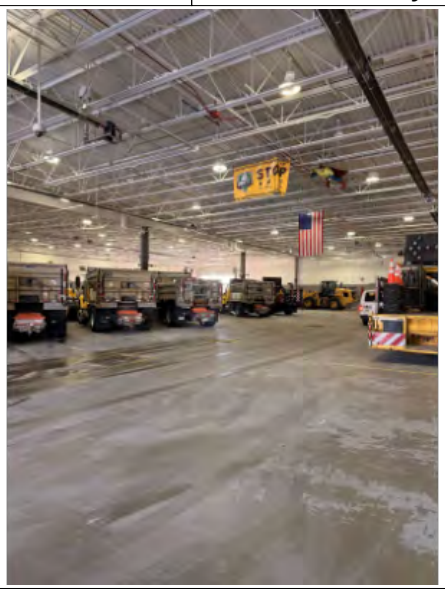
Task ID: 25-122932		Asset ID: Facility Site M02			
Photo No.	4	Date	11/14/2025	Time	1:30 PM
Comments:		Direction	South	Photo Taken By	ReganW
Facility is clean and free of trash & debris

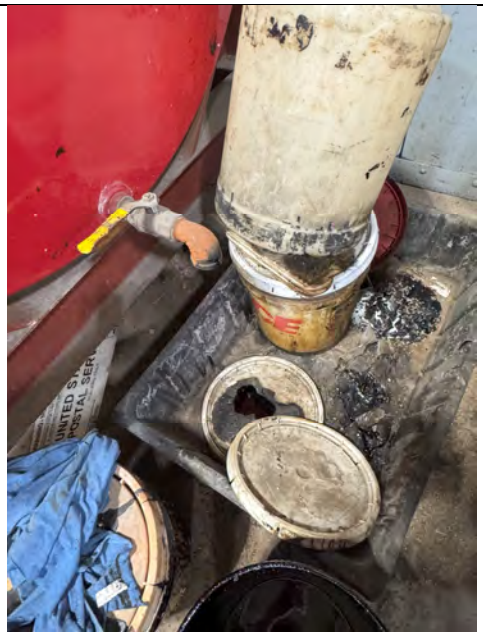
Drip pan placed below emulsion tank valve.

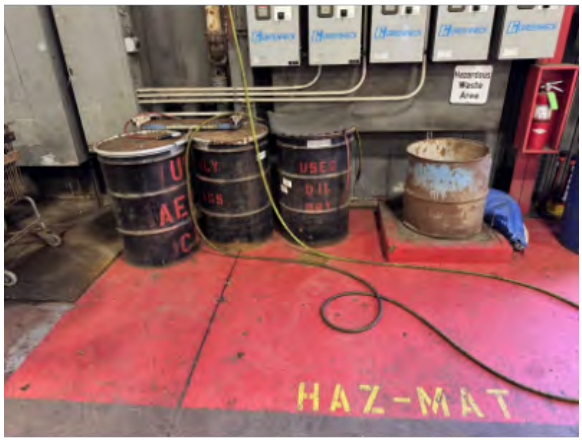
Task ID: 25-122942		Asset ID: Facility Site M03			
Photo No.	4	Date	11/7/2025	Time	11:00 AM
Comments:		Direction	West	Photo Taken By	GiffordG
Hazardous waste area clean and labeled

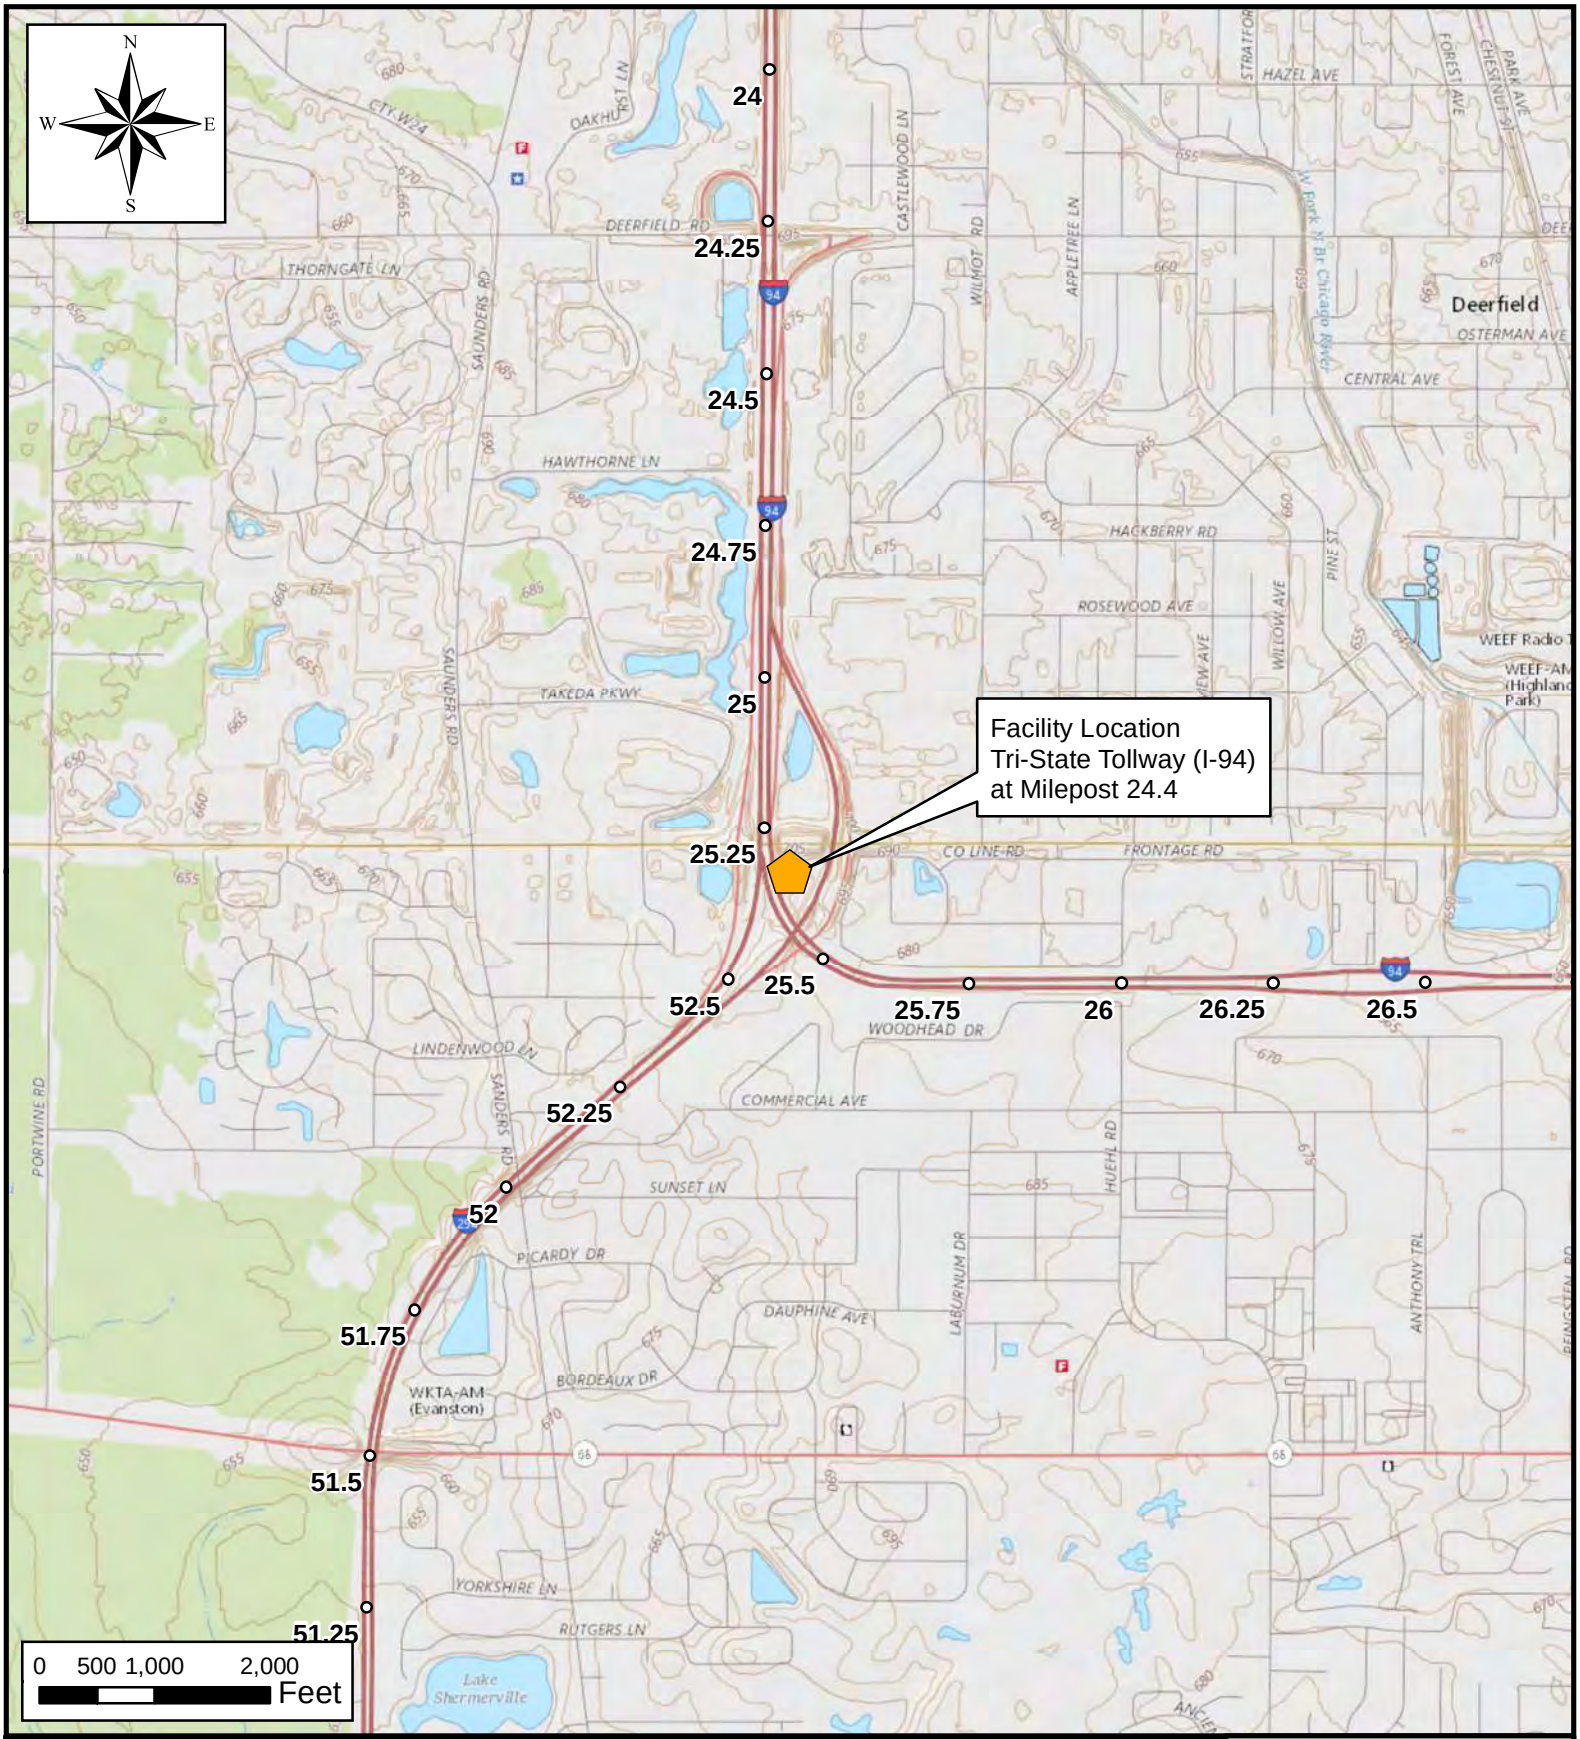
Task ID: 25-122944		Asset ID: Facility Site DRFSD			
Photo No.	2	Date	11/7/2025	Time	9:30 AM
Comments:		Direction	South	Photo Taken By	GiffordG
Spill kit located near fuel AST

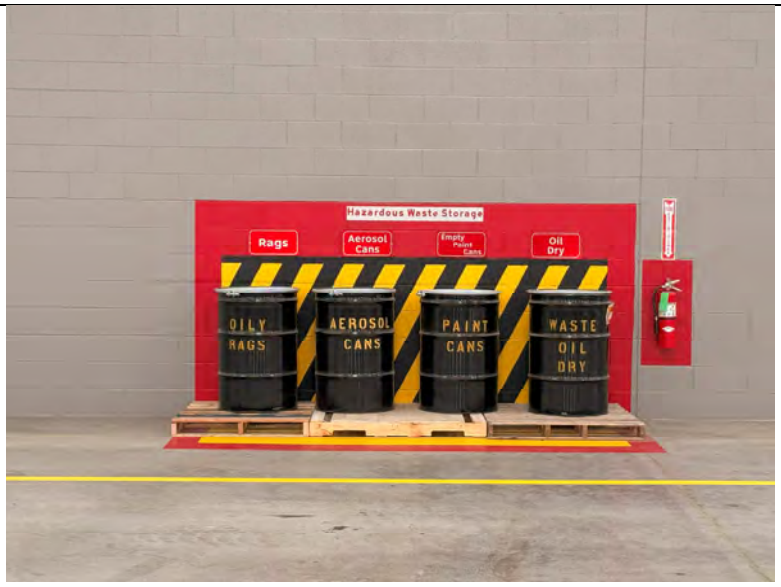
Photo No.	4
Date	6/05/2025
Time	1:10 PM
Direction	West
Photo Taken By	GG

Hazardous waste storage area

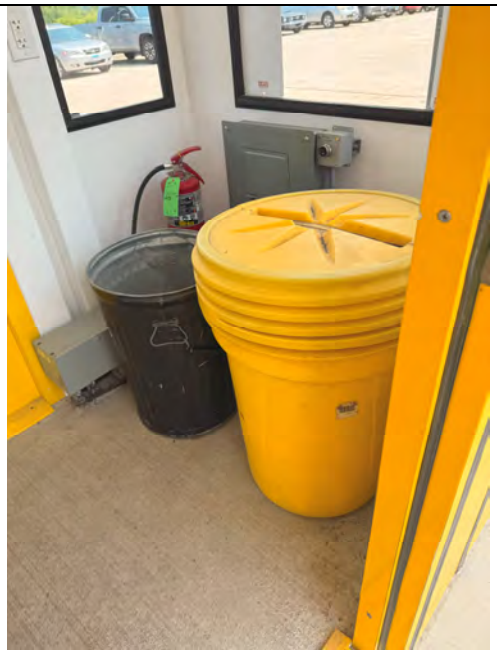
Photo No.	6
Date	6/05/2025
Time	1:20 PM
Direction	West
Photo Taken By	GG
Comments Spill kit located at the fueling station

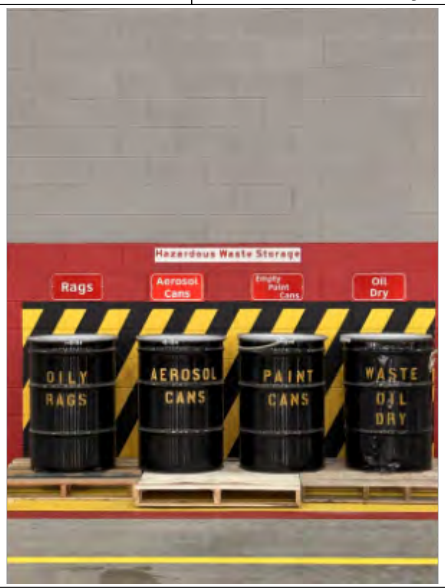
Task ID: 25-122945		Asset ID: Facility Site M05			
Photo No.	1	Date	11/17/2025	Time	9:00 AM
Comments:		Direction	North	Photo Taken By	ReganW
Hazardous waste area clean, organized, and labeled

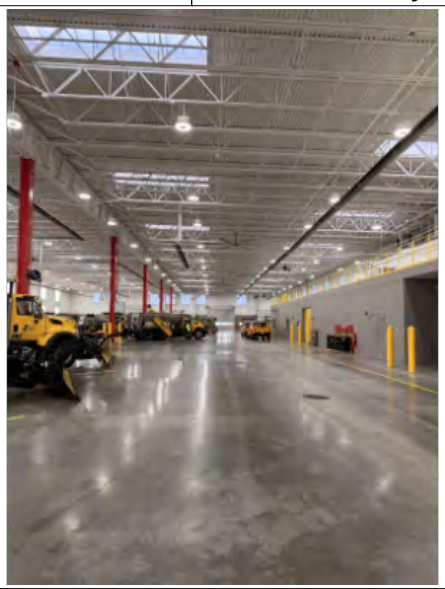
Task ID: 25-122945		Asset ID: Facility Site M05			
Photo No.	2	Date	11/17/2025	Time	9:00 AM
Comments:		Direction	West	Photo Taken By	ReganW
Facility clean and free of trash & debris

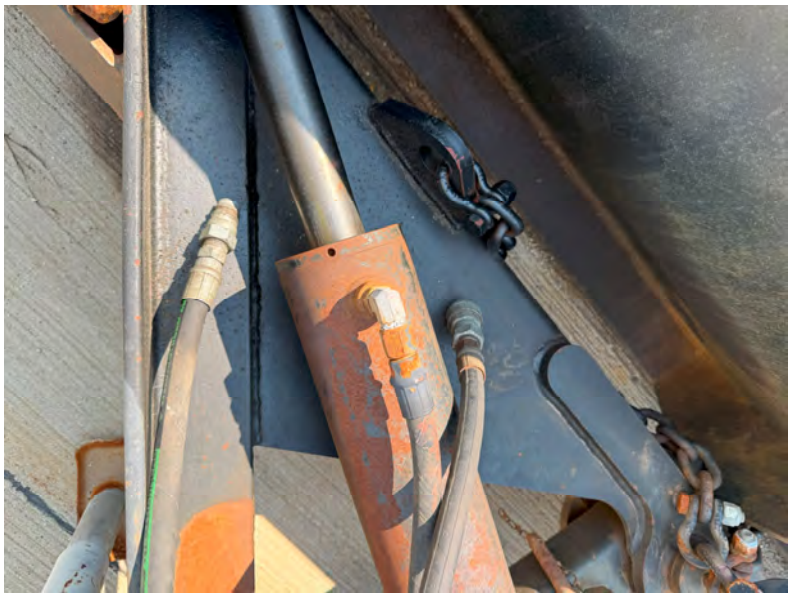
Action Item: Keep hydraulic lines capped/wrapped when not in use.

RESOLVED (7/16/25)

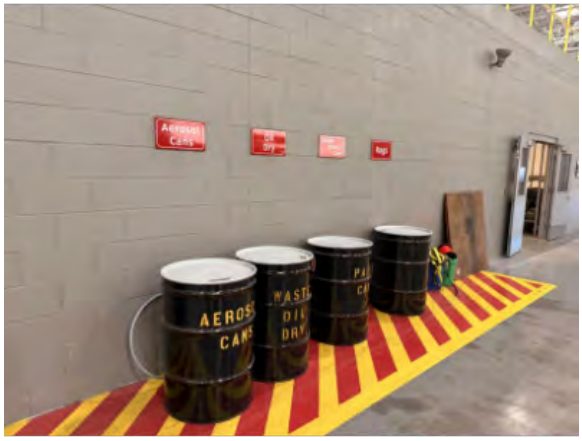
Task ID: 25-122946		Asset ID: Facility Site M06			
Photo No.	1	Date	11/17/2025	Time	11:00 AM
Comments:		Direction	West	Photo Taken By	ReganW
Action Item: Remove non-hazardous materials from hazardous waste area

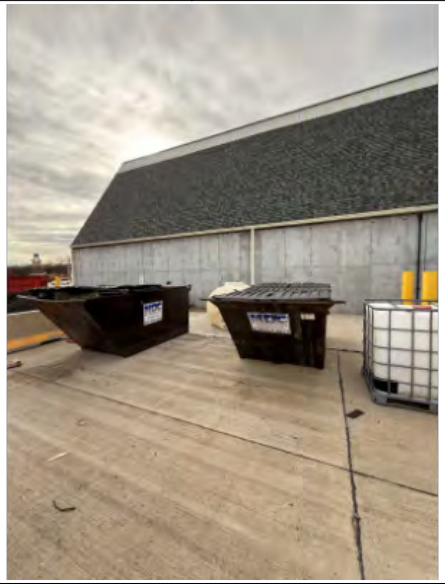
Task ID: 25-122946		Asset ID: Facility Site M06			
Photo No.	4	Date	11/17/2025	Time	11:00 AM
Comments: Dumpster lids closed		Direction	West	Photo Taken By	ReganW

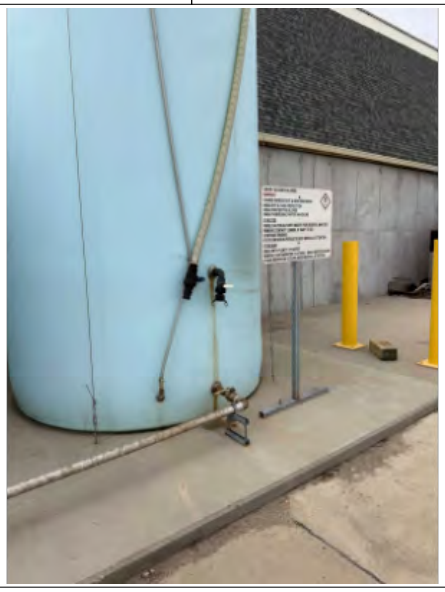
Task ID: 25-122946		Asset ID: Facility Site M06			
Photo No.	5	Date	11/17/2025	Time	11:00 AM
Comments:		Direction	South	Photo Taken By	ReganW
Calcium Chloride AST valve closed

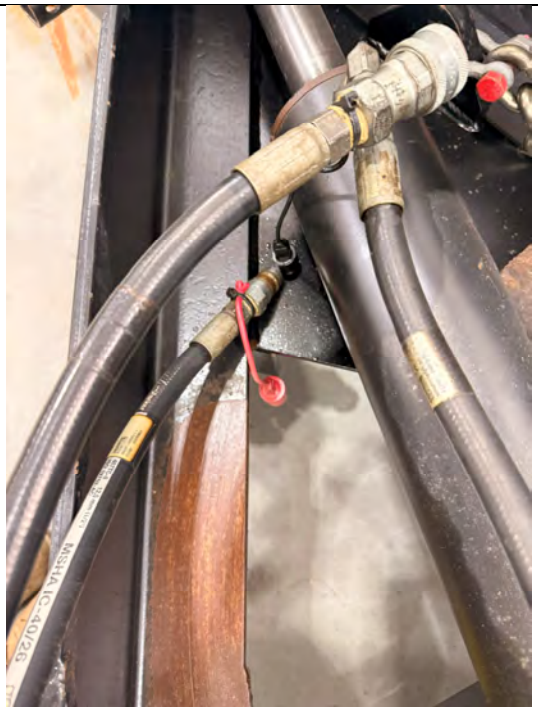
Action Item: Cap/wrap hydraulic oil lines when not in use

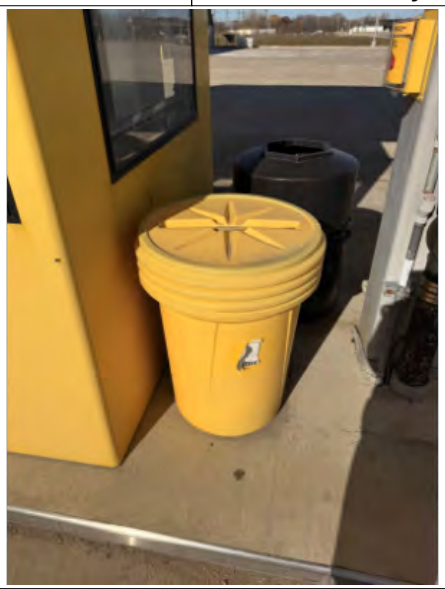
Task ID: 25-122937		Asset ID: Facility Site M08			
Photo No.	2	Date	11/12/2025	Time	1:00 PM
Comments:		Direction	North	Photo Taken By	ReganW
Spill kit present at fueling island

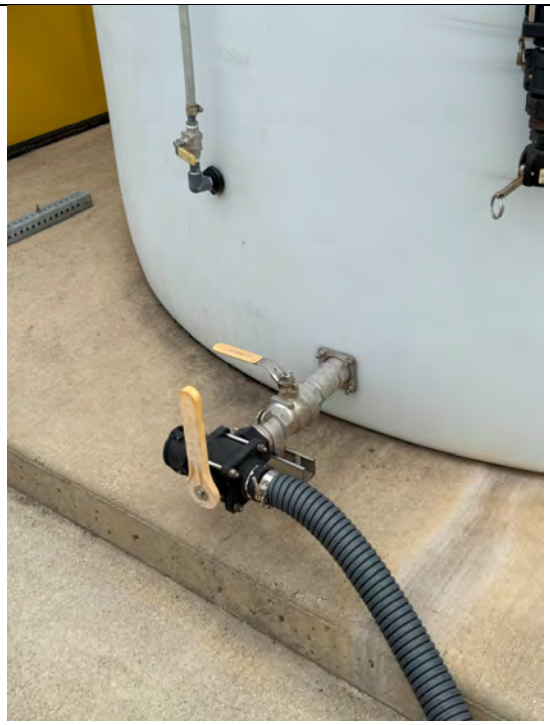
Salt brine AST valve in closed position

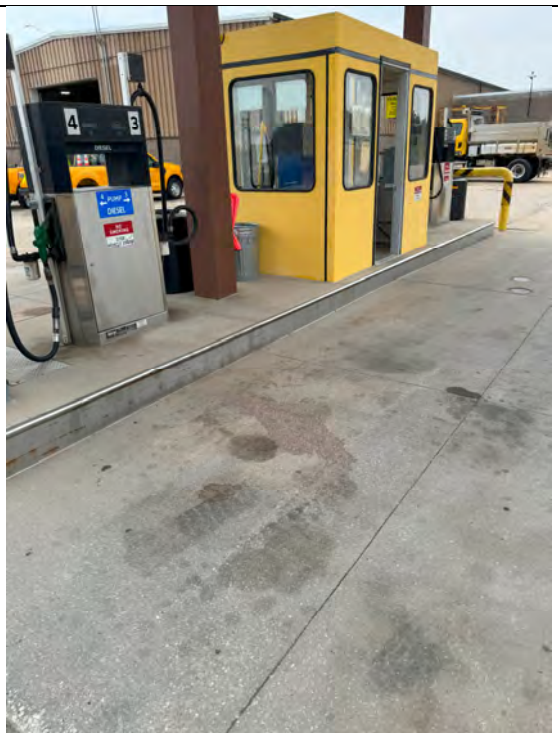
Action Item: Clean up used oil dry at fueling station

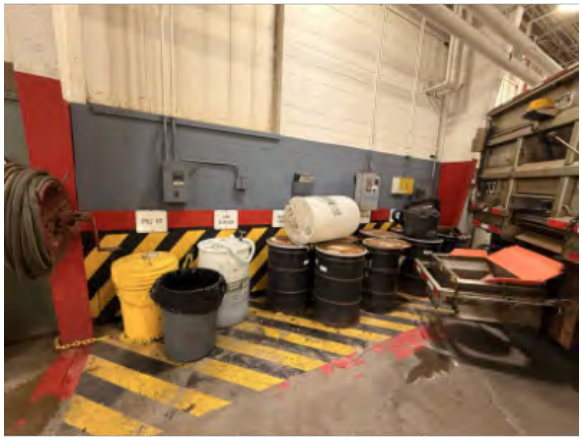
Task ID: 25-122941		Asset ID: Facility Site M11			
Photo No.	1	Date	11/12/2025	Time	8:30 AM
Comments:		Direction	West	Photo Taken By	ReganW
Action Item: Remove empty barrel and vacuum from hazardous material storage area **RESOLVED (11/24/25)**

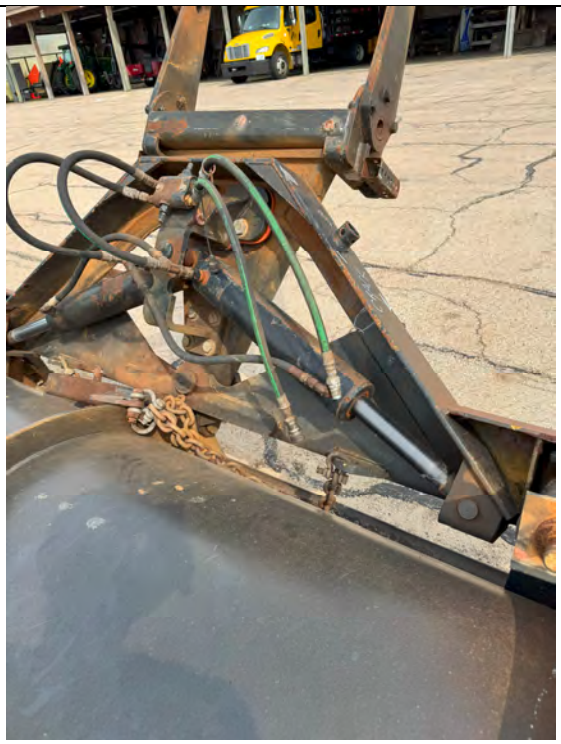
Action Item: Cap/wrap hydraulic oil lines

RESOLVED (7/17/25)

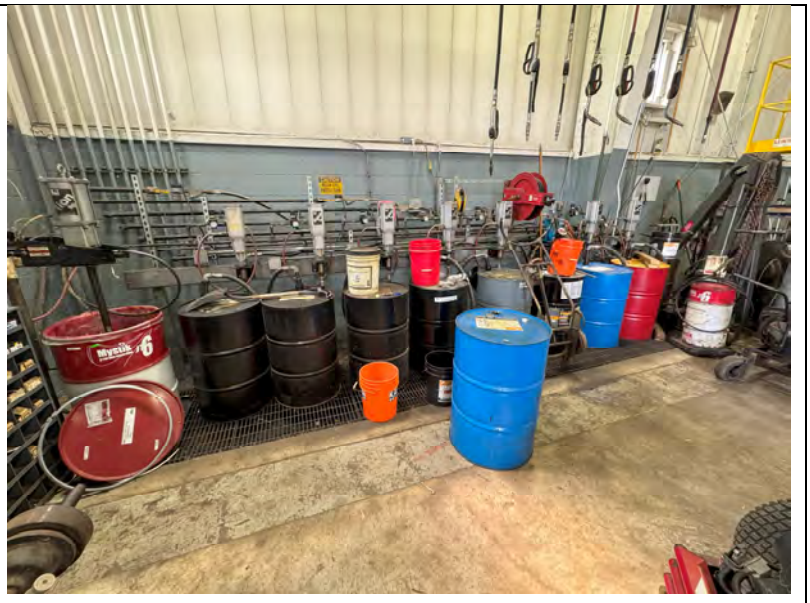
Bulk Oil Distribution Area

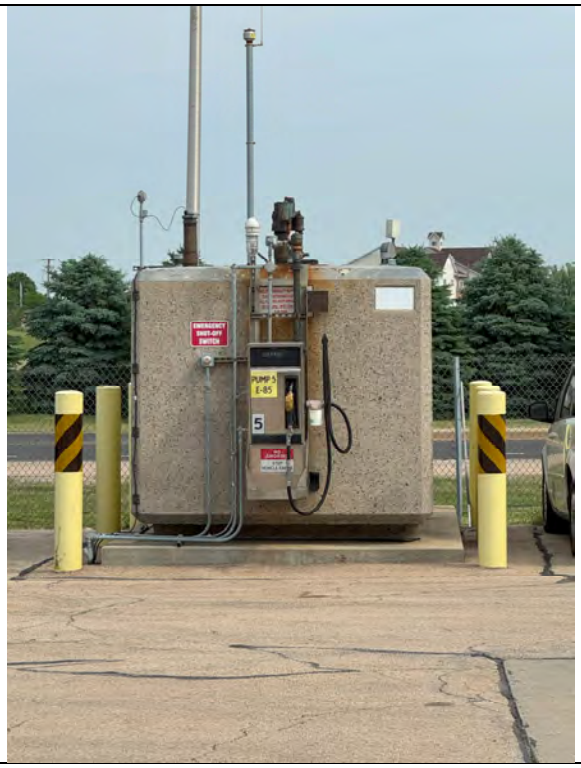
Photo No.	5
Date	6/03/2025
Time	9:40 AM
Direction	East
Photo Taken By	GG
Comments Fuel AST

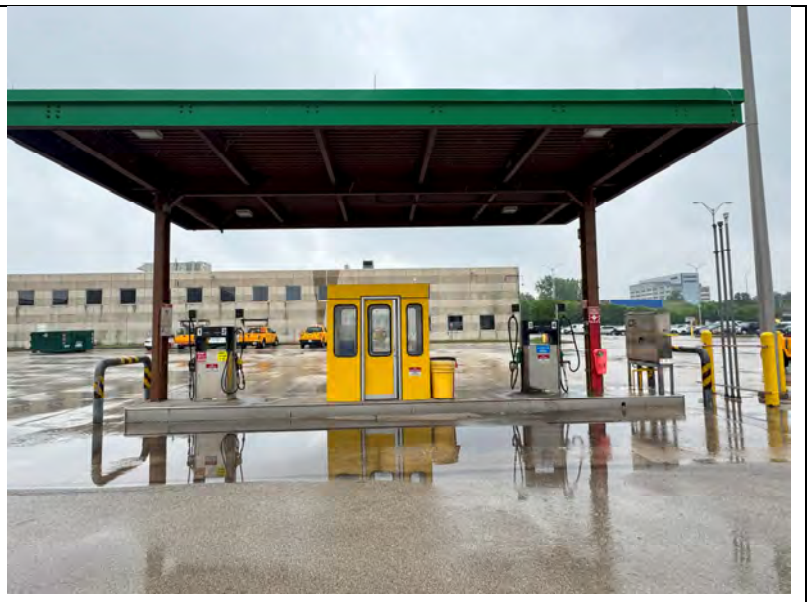
Photo No.	3
Date	6/04/2025
Time	7:45 AM
Direction	East
Photo Taken By	GG
Comments Fueling island

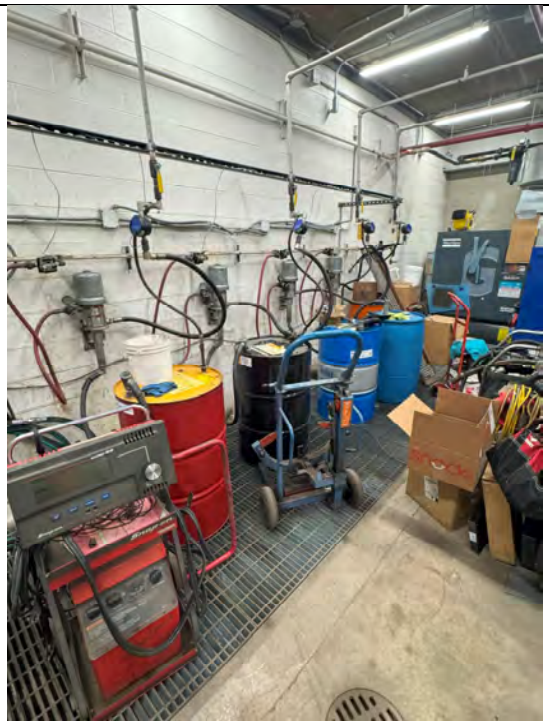
Bulk oil storage/ distribution

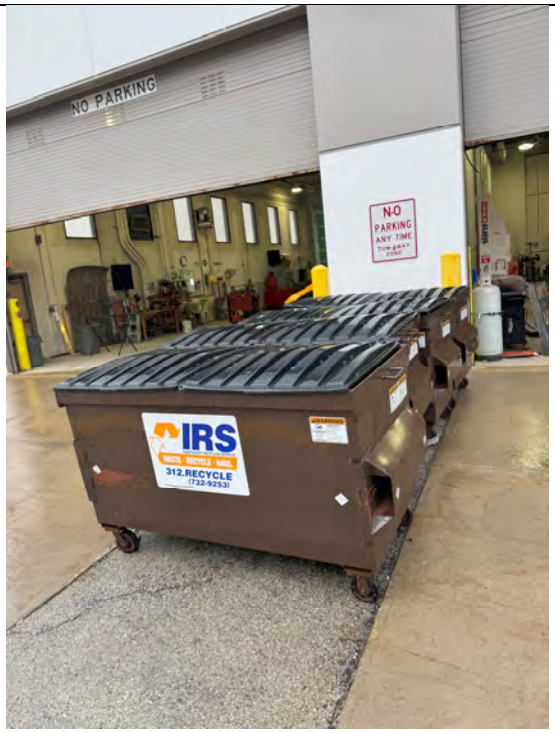
Photo No.	1
Date	6/04/2025
Time	8:05 AM
Direction	South
Photo Taken By	GG
Comments Dumpster lids closed

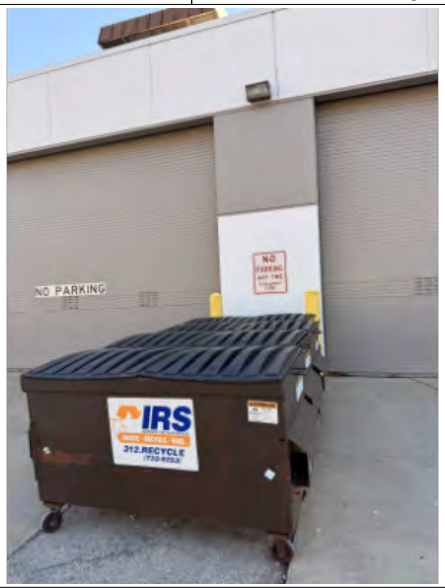
Task ID: 25-122940		Asset ID: Facility Site CNTSP			
Photo No.	1	Date	11/14/2025	Time	9:00 AM
Comments: Dumpster lids closed		Direction	East	Photo Taken By	ReganW

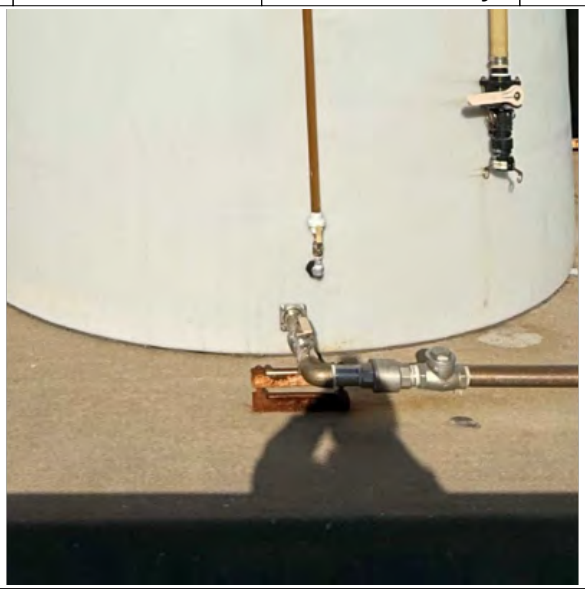
Task ID: 25-122948		Asset ID: Facility Site SCMNT			
Photo No.	2	Date	11/14/2025	Time	10:30 AM
Comments: Action Item: Close brine AST valve when not in use		Direction	North	Photo Taken By	ReganW

3	Are the AST valves in the closed position when not in use?	Yes
Notes/Corrective Action Items including schedule for implementation:		
BEET HEAT/SALT BRINE ABOVEGROUND STORAGE TANK (IF APPLICABLE)		(Select One)
1	Tank contents: Beet heat/salt brine?	Brine
2	Is the AST area free of leaks, stains or spills?	Yes
3	Are the pump and hoses in good condition (no cracks, etc.)?	Yes
4	Are the AST valves in the closed position when not in use?	No
Notes/Corrective Action Items including schedule for implementation: - Close brine AST valves, see photo #2		
MISCELLANEOUS AREAS		(Select One)

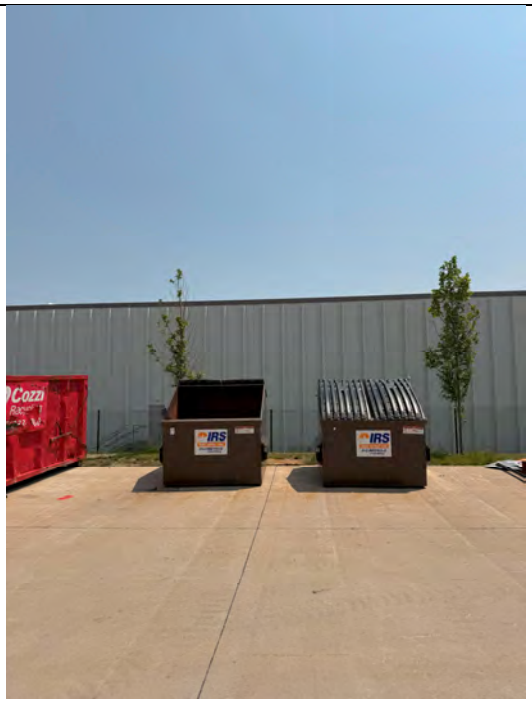
Action Item: Keep dumpster lids closed to prevent stormwater contamination.

GOOD HOUSEKEEPING		(Select One)
1	Are drums kept indoors neat, clean, and orderly?	Yes
2	Are storm drains/storm water ditches in the plant yard free of obstructions, debris, etc.?	Yes
3	Are the bulk material loading and unloading areas free of oil/grease staining (unleaded and diesel fuel, used oil, emulsion, 55-gallon drums)?	Yes
4	Are empty drums and totes stored in the designated area?	Yes
5	Are the empty drums and totes capped/covered and free of surface residue?	Yes
6	Are front-end loaders or other loading equipment working properly (no fluid leaks)?	Yes
7	Is the facility generally free of trash and debris?	Yes
8	Is the employee parking and common areas free of trash and debris?	Yes
9	Are the flammable cabinets in good condition (no rusting, corrosion, free of leaks, etc.)?	Yes
10	Are the waste dumpsters covered when not in use?	No
Notes/Corrective Action Items including schedule for implementation: - keep dumpster lids closed to prevent stormwater contamination, see photo #1

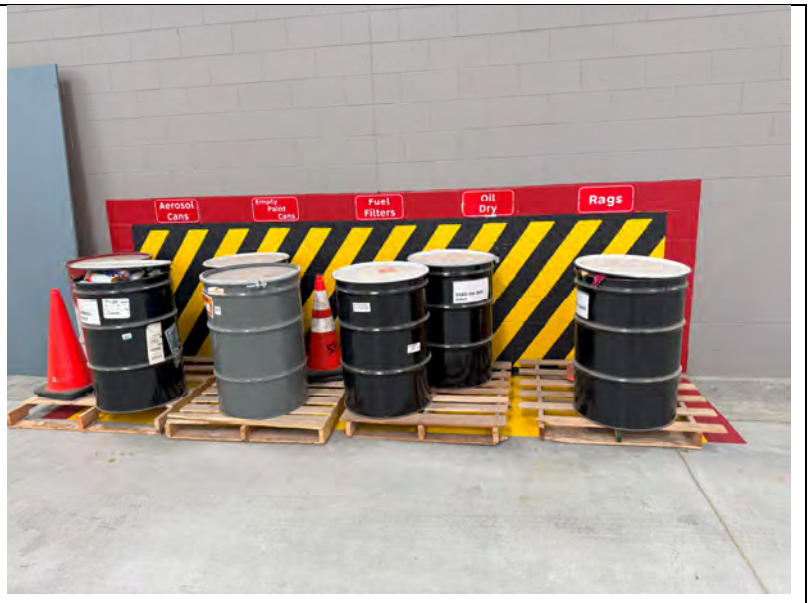
Photo No.	2
Date	6/05/2025
Time	12:20 PM
Direction	Southeast
Photo Taken By	GG

Hazardous waste storage area

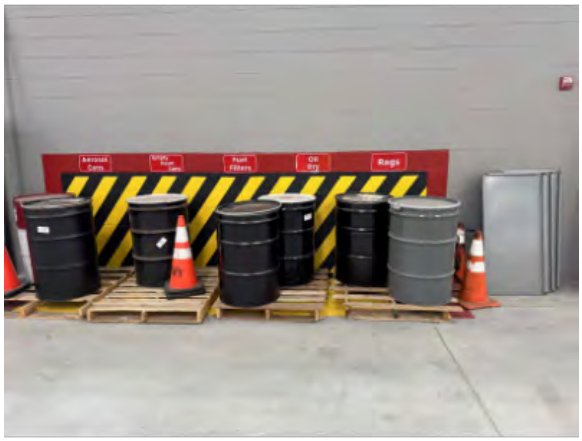
Task ID: 25-122947		Asset ID: Facility Site M16			
Photo No.	2	Date	11/7/2025	Time	1:00 PM
Comments: Hazardous waste area clean, labeled, and organized		Direction	South	Photo Taken By	GiffordG

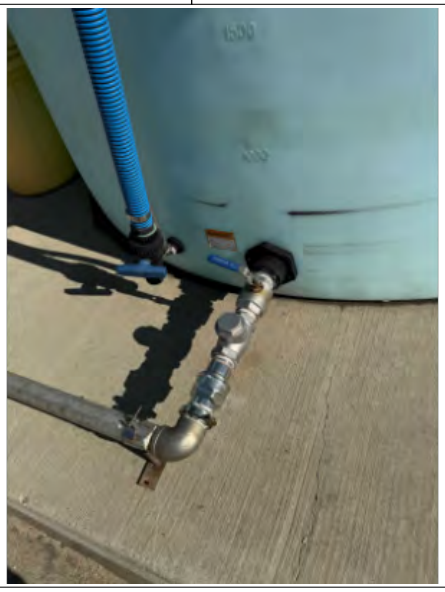
Task ID: 25-122947		Asset ID: Facility Site M16			
Photo No.	5	Date	11/7/2025	Time	1:00 PM
Comments:		Direction	East	Photo Taken By	GiffordG
Calcium Chloride AST valves closed

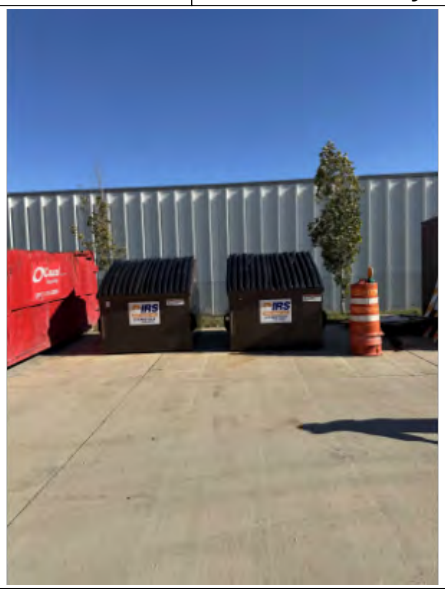
Task ID: 25-122947		Asset ID: Facility Site M16			
Photo No.	6	Date	11/7/2025	Time	1:00 PM
Comments:		Direction	East	Photo Taken By	GiffordG
Dumpster lids closed
